Purpose:

Determine the general effect of Concrete Cloth hydration on water pH.

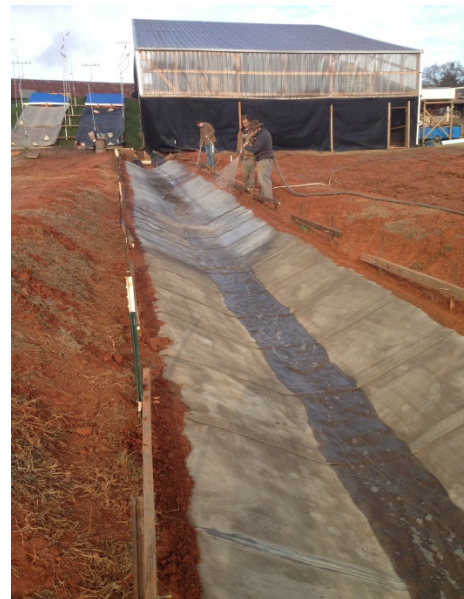
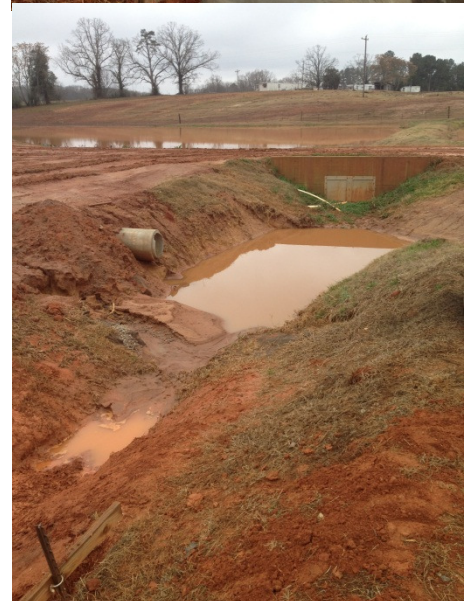
Approximately 1000 square feet of Concrete Cloth was installed at the TRI Environmental test facility near Clemson South Carolina. The primary purpose for the installation was to measure the Manning's "n" coefficient. A secondary purpose was to get an idea of the effect of Concrete Cloth hydration water on the pH of two small basins downstream from the test channel. The photo to the right shows the hydration process of the channel. All of the excess hydration water ran first into a small stilling basin that was less than 2 cubic feet before the hydration process and swelled to about 5 cubic feet then overflowed into the larger stilling basin that swelled from about 100 cubic feet to something less than 300 cubic feet. The larger reservoir in the background of the photo was kept completely separate from these two basins.

The pH of the hydration water was determined before it came in contact with the Concrete Cloth. Then samples were taken from the basins after the Concrete Cloth was hydrated. The effect on pH appears to have been reduced for the large basin. The most obvious reason for this is that the elevated pH from the excess hydration water was diluted by the original volume of water that was present before hydration began. Among the secondary factors affecting this result may have been the water coming into contact with the soil (soil pH is unknown) after exiting the Concrete Cloth channel and the pH of rain water running off a nearby gravel lot.
