**Purpose:**

Determine the effects of UV exposure on the physical properties of Concrete Cloth. CC8 samples were prepared for UV exposure. 13"x14" cut pieces were submerged in 70 degree Fahrenheit water bath for 6 minutes, and were then allowed to cure flat between steel plates for 28 days in a room conditioned at 70 Fahrenheit and 50% relative humidity. The samples were cut on a tile saw to target dimensions of 2"x6".

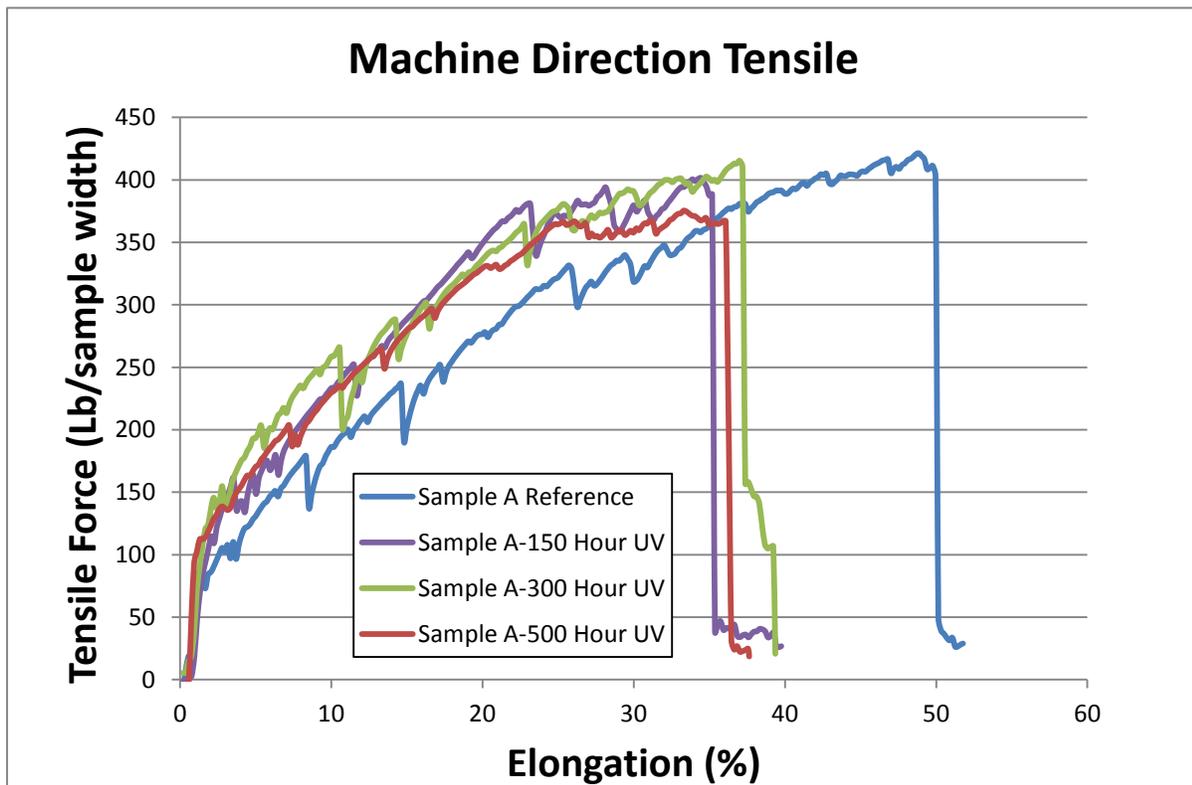
A plot of load versus percent elongation shows that as the tensile force is applied to the Concrete Cloth, there is a point early on the load versus elongation curve where the concrete cracks and the modulus changes. This is shown as a change in the slope on the load versus elongation curve. The data presented in the table for the ultimate tensile failure is where the fiber matrix fails. There appears to be a trend for the product to fail at a lower elongation when exposed to greater and greater amounts of UV. The maximum tensile

strength decreases a little when exposed to greater amounts of UV light retaining more than 90% strength at 500 hours. The cement in the sample may be experiencing additional curing during the UV exposure (it is being exposed to moisture and heat) which may explain some of the behavior, especially the increase of the tensile force at lower elongations.
